NAVAL AIR WARFARE CENTER AIRCRAFT DIVISION
PATUXENT RIVER, MARYLAND

REPORT NO: NAWCADPAX--97-249-TR

HIGHLY DAMPED STRUCTURE PART II

NAWCADPAX--97-249-TR
4 December 1997

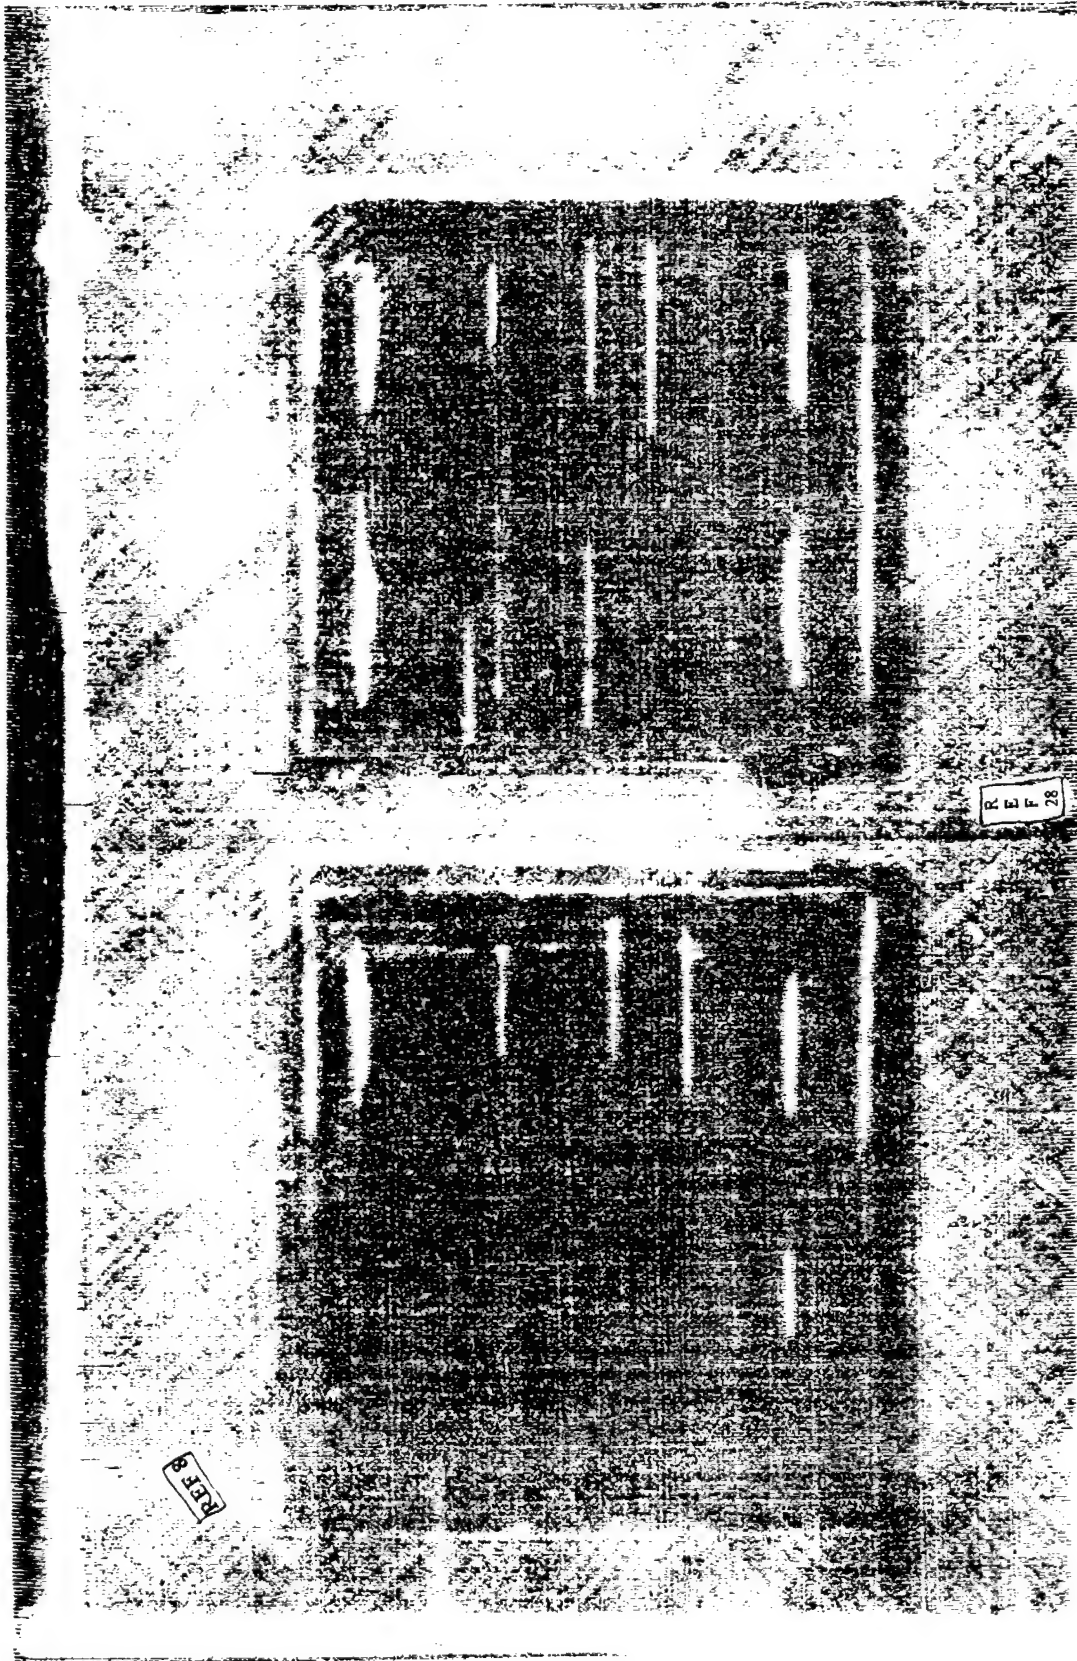
Figure A-18
C-SCAN OF DAMPED PANEL, TWO DAMPING SECTIONS

After curing, the panels were inspected for voids. C-scans showed that the ISD-110 film had achieved good bonding during the cure process (figures A-18 and A-19). A photomicrograph of the trim from the panel is shown in figure A-20. As with other cocured fabrications using 3M damping materials, there was no evidence of excessive flow, absorption into the epoxy, or thermal degradation of the damping material.
